# **Forced Performance 2004-2007 Subaru 2.5l Bulletin 12/1/07, UPDATE 9/1/08**

## **Oil Starvation of Turbos on Subaru Vehicles: Why and How.**

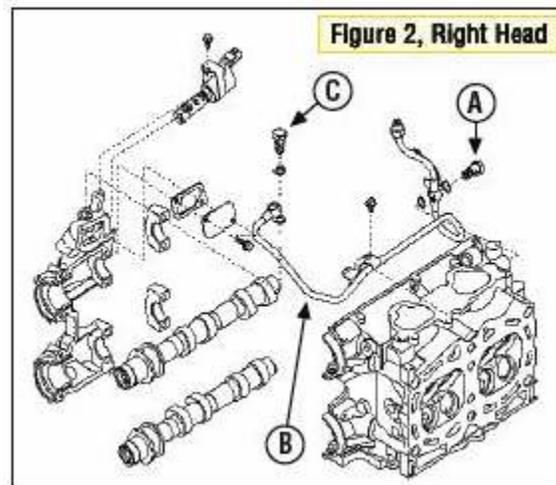
Turns out that there is an oil filter screen built into the factory oil feed banjo bolt at the cylinder head, and Subaru wants it removed completely in order to avoid turbocharger oil starvation and failure. The Subaru Service Technicians (from dealerships) we interviewed on this subject reported recurring turbocharger failures even on completely stock 2.5 WRX, STi, Forrester and Baja vehicles due to this problem, prompting an Official Subaru Service Bulletin in October 2007. Material collected in these screens consisted of mainly gummy sludge and carbon with flakes of metal from various internal engine components. In one reported case in Alabama, even a low mileage 05 Baja which had all its regular 3k mile oil changes at the dealership experienced a stock turbocharger failure due to this oil filter becoming plugged with sludge.

The turbocharger filter can be seen in the diagram below, it is marked "A"

***"the mesh screen which is located inside the banjo bolt that secures the turbo-charger oil supply pipe to the back of the right side cylinder head should be checked to make sure it is not clogged or restricted especially if the condition of the oil is questionable or as to when the last oil change was performed. If clogged or restricted, it will reduce or cut off the oil supply to the turbo resulting in failure. The oil supply pipe should also be checked to make sure that there are no obstructions."***

Forced Performance recommends REMOVING this "Turbocharger Oil Supply Mesh Screen" in all vehicles running our FPGreen and Red model turbochargers. The thrust bearing used in these turbochargers has very little tolerance for reduced or limited oil supply. In fact this bearing actually requires approximately TWICE the oil volume as a stock IHI turbocharger and can die a quick and sure death if fed its life giving oil through one of these restricted filters. It is also completely possible that a slightly restricted filter will

We also wish to point out that the picture of the banjo bolt and filter shown in the Service Bulletin appears to have the filter oriented BACKWARDS. To avoid confusion about which way to install the filter, simply eliminate the filter by picking it out of the banjo bolt and discarding it as soon as possible.

To clarify – REMOVE THE FILTER SCREEN FROM ALL BANJO BOLTS.
