SERVICE BULLETIN

APPLICABILITY: All Vehicles Equipped with Turbo
SUBJECT: Turbocharger Mesh Filter Screen

NUMBER: 02-106-08
DATE: 08/26/08

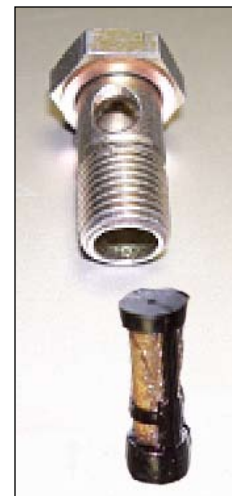
It is possible that the turbo oil supply mesh filter, which is located inside the banjo bolt that secures the turbocharger oil supply pipe to the back of the right side cylinder head, may become clogged thereby preventing oil supply to the turbo resulting in failure. Therefore it is required that this filter screen be checked for obstructions any time a Turbocharger is being replaced for a failure.

- **Note:** The mesh filter screen is only available with a replacement banjo bolt. (P/N 14445AA090) Tightening torque: 29 N•m (3.0 kgf-m 21.4 ft-lb).
- **Note:** Anytime the banjo bolt is removed or replaced, both copper washers must be replaced with new ones.
- Make sure the mesh filter screen is installed in the proper direction; incorrect installation will prevent oil supply to the turbocharger. (Note direction, in picture to the right).
- **Do not confuse** the turbocharger oil supply mesh filter screen with the Active Valve Control System (AVCS) union screw mesh filter screen. Refer to Service Bulletin 02-97-05, dated 10/06/05.

If the mesh filter screen is found to be obstructed it should be cleaned or replaced. Obstructions could be sludge due to poor engine oil maintenance or harsh driving conditions. Further diagnosis may be required if significant amounts of sludge, metal, and/or other materials are found in the mesh filter screen. In any turbocharger replacement, sufficient oil pressure to the turbocharger should be verified. Please consult the service manual for the appropriate specification.

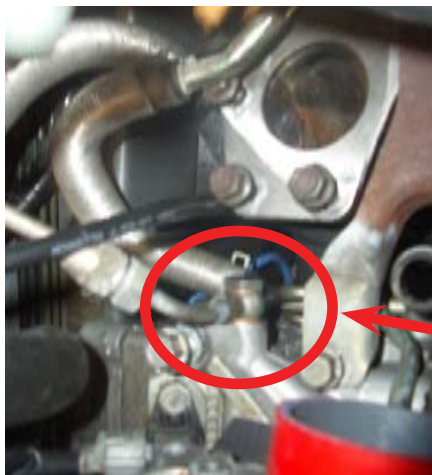
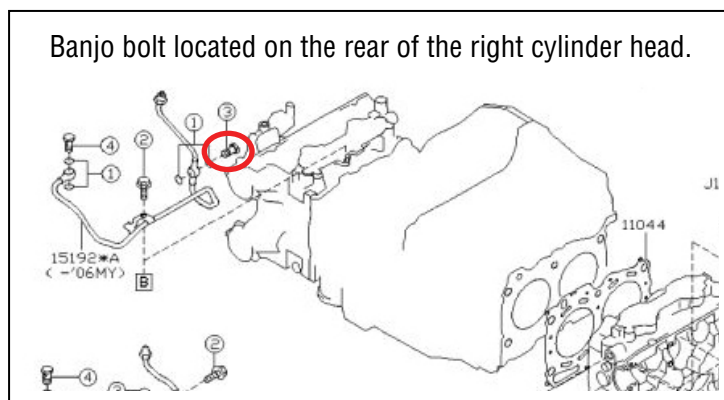
Shown with
Turbo removed.
